REPORT TO THE SECRETARY-GENERAL
ON THE SCOPE AND NATURE OF DAMAGE
INFLICTED ON THE KUWAITI INFRASTRUCTURE
DURING THE IRAQI OCCUPATION

LETTER DATED 26 APRIL 1991 FROM THE SECRETARY-GENERAL ADDRESSED TO THE PRESIDENT OF THE SECURITY COUNCIL

BY A UNITED NATIONS MISSION, LED BY MR. ABDULRAHIM A. FARAH, FORMER UNDER-SECRETARY-GENERAL, ASSESSING THE SCOPE AND NATURE OF DAMAGE INFLICTED ON KUWAIT'S INFRASTRUCTURE DURING THE IRAQI OCCUPATION OF THE COUNTRY FROM 2 AUGUST 1990 TO 27 FEBRUARY 1991

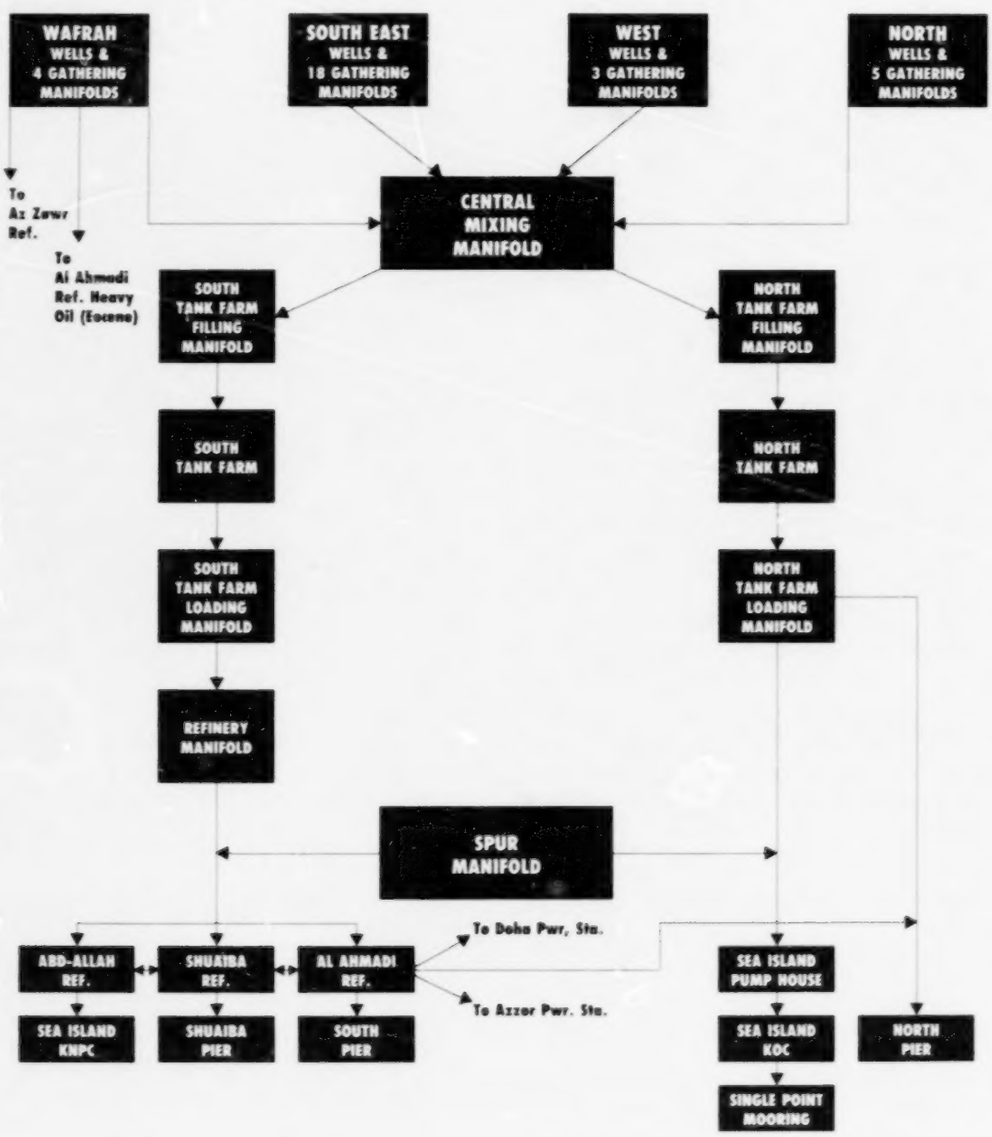
FIGURE 1

87. The central mixing manifold was heavily damaged but the filling manifolds for the south and north tank farms are intact. Damage to the two tank farms is major. Of the 35 tanks comprising the south tank farm, with a total storage capacity of 6 million barrels, 14 tanks were destroyed and 2 were damaged, for a lost capacity of about 3.3 million barrels, or 55 per cent. The south tank farm is mostly used to service the refineries but it is also connected to the north tank farm and the crude export facilities through a spur manifold. Of the 24 tanks that comprise the north

tank farm, with a total storage capacity of 8 million barrels, 8 tanks were destroyed and 1 was damaged, for a lost capacity of about 3.7 million barrels, or 46 per cent. The north tank farm is basically dedicated to offloading crude for export. The two loading manifolds, which are downstream from the tank farms, were said to have been destroyed by Allied precision bombing in an effort to stem the flow of large quantities of crude oil that was being released into the Persian Gulf.

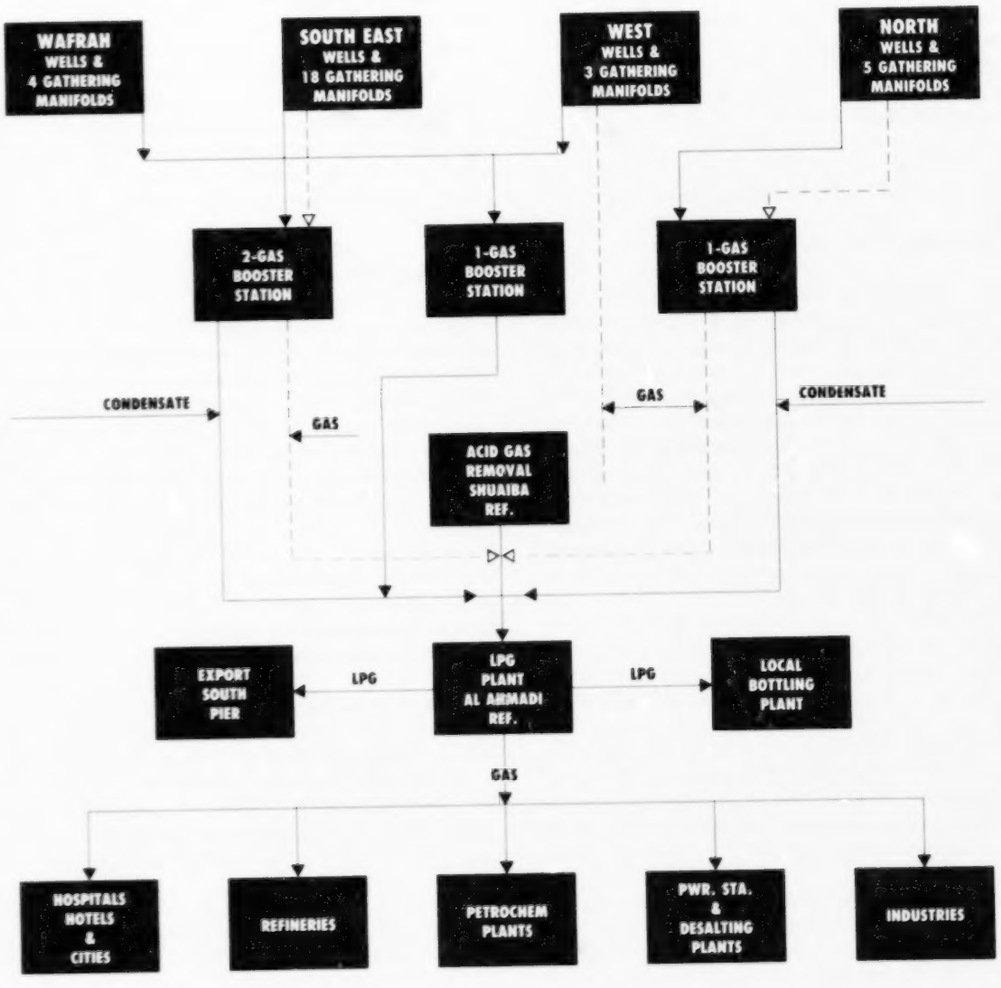
FIGURE 2

105. The occupation brought an end to the production of natural gas and LPG. Most of the natural gas is either burning or escaping with the gushing oil from those wells that have not been set on fire. Of the four gas booster stations, the one in west Kuwait

was destroyed, another in north Kuwait was severely damaged and, of the two in south-east Kuwait, one was partially damaged and the other appears to be in good condition.

106. The LPG plant remains intact, as is the LPG bottling plant. However, 40,000 LPG cylinders and 45,000 regulators were looted and allegedly removed to Iraq.
